**Re: *Phase II Environmental Site Assessment Update for Knife River Property***  
***AWC Project No. 491.11***

# Phase II Environmental Site Assessment Update

Knife River Property  
(former McElroy & Wilken Gravel Pit)  
Kalispell, Montana

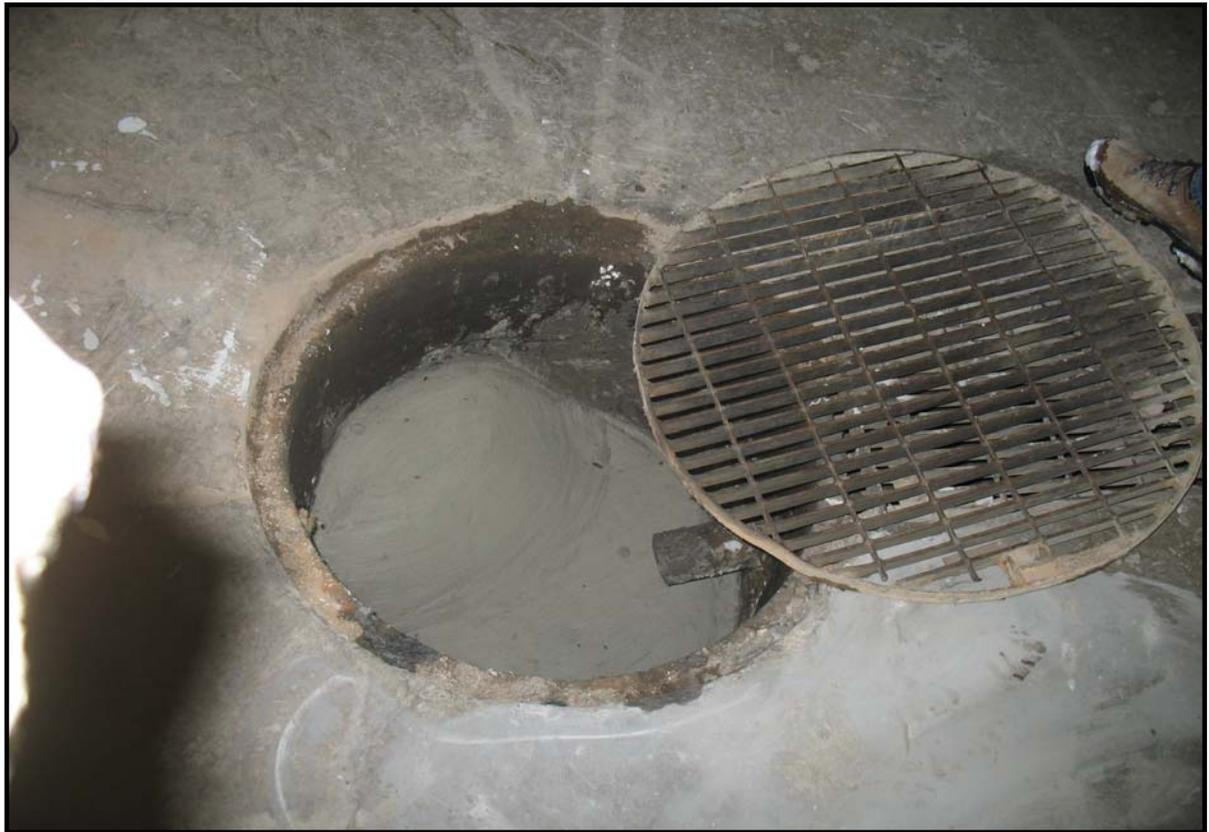
Photograph No. 1 - View of floor drain sump inside Truck Repair Shop after being filled with concrete grout to seal-off flow to oil-water separator and exterior sump. Photo by AWC December 16, 2011.

The contents of both the exterior sump and the oil-water separator were pumped out on December 13, 2011 by Arrow Power Vac of Missoula, Montana. The oily water and sludge material was transported to Missoula for processing and recycling. After removing the residual liquids, KRC personnel plugged the outlet pipe inside the truck repair shop with cement grout to seal it from connecting to the exterior sump or oil-water separator (see photograph no. 1 in Appendix A).

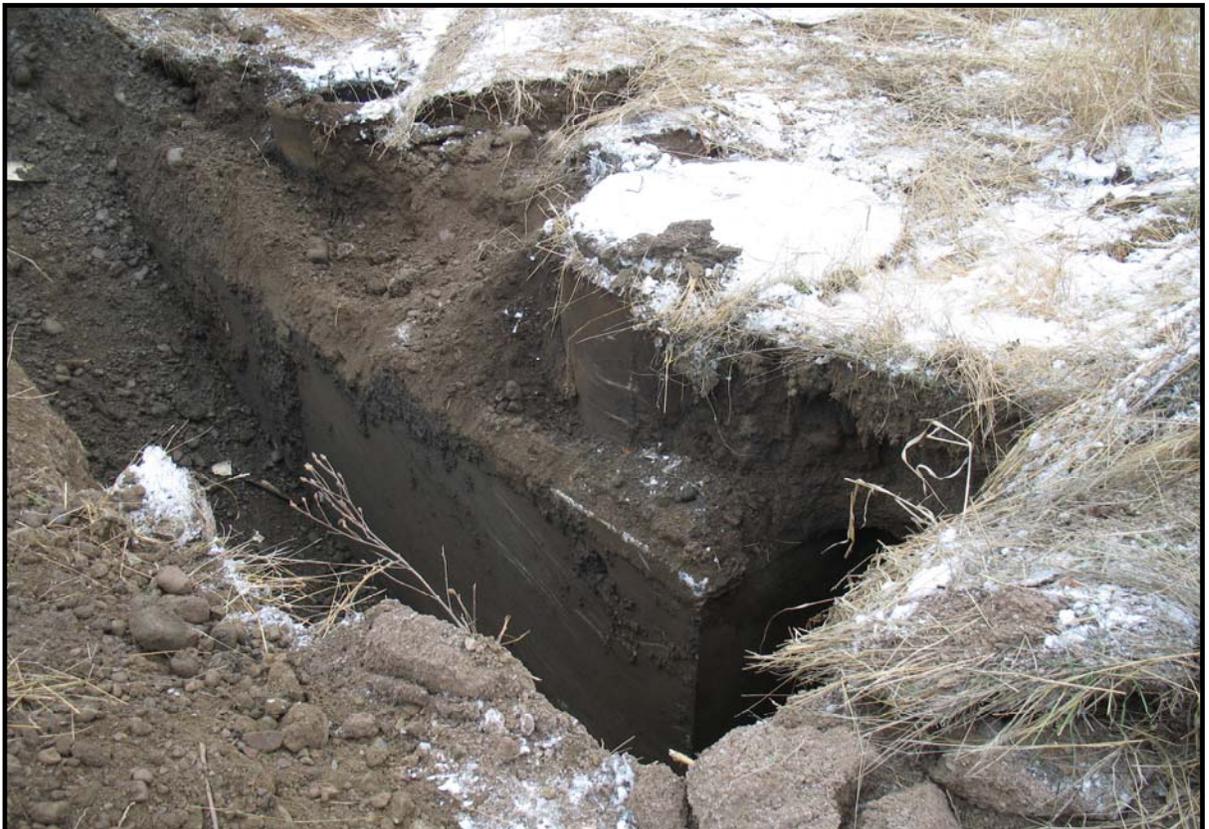
Photograph No. 2 - Top of northwest corner of oil-water separator during initial stage of excavation. Note 2-foot riser on top of tank that is level with ground surface. Photo by AWC December 16, 2011.

KRC personnel used a John Deere excavator to exhume and expose the top of the oil-water separator cover (see photograph no. 2 in Appendix A). Upon determining the dimensions and layout of the separator, a trench was excavated adjacent to the north side to allow for inspection and further assessment (see photograph no. 3 in Appendix A). A number of knockouts are located at the top of each tank. It was determined the plastic seals were still intact and the knockouts did not appear to be leaking (see photograph no. 4 in Appendix A). The seal between the tank cover and reservoir was also found to be intact and there were no signs of leakage. Oil-water separator excavation proceeded by removing the concrete cover on each tank and then breaking the walls of the reservoir into manageable pieces that could be lifted by the excavator (see photograph nos. 5 and 6 in Appendix A).

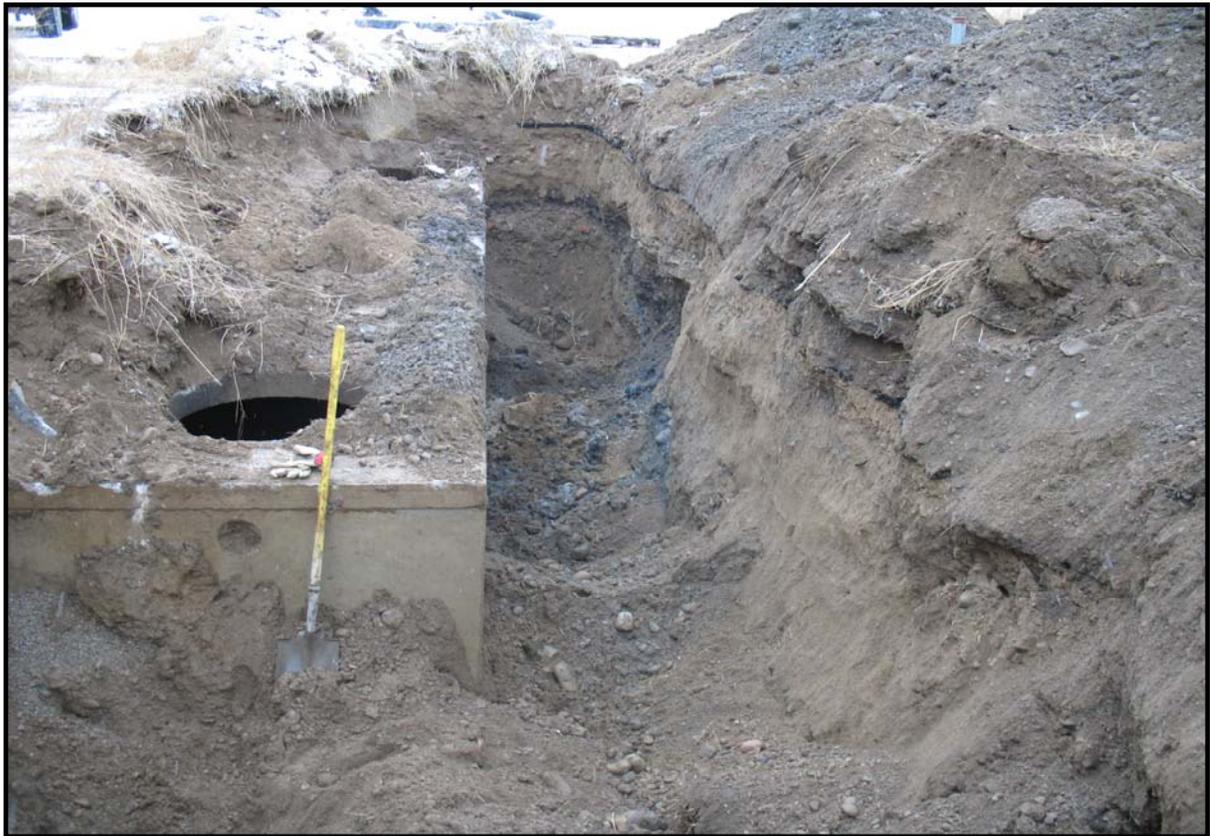
Photograph No. 3 - View looking due west along length of oil-water separator. Note black discolored soils on right side (north wall) of excavation. Photo by AWC December 16, 2011.

The soil sample results confirm the soil staining and odor associated with the sample collected from the north wall of the oil-water separator excavation is related to the wastewater from the septic tank serving the truck repair shop. The north lateral of the drain tile parallels the oil-water separator in this area.

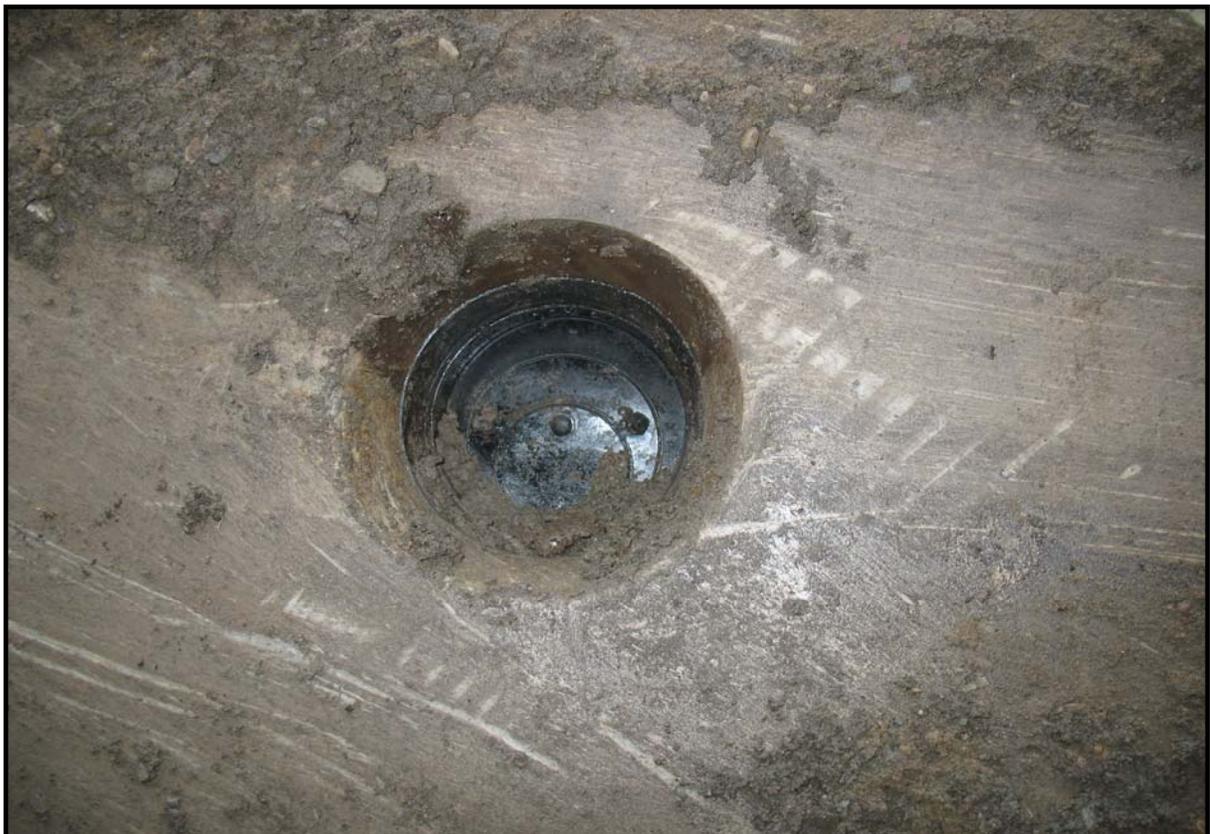
Photograph No. 4 - Closeup view of knockout showing it is intact and has not leaked. Photo by AWC December 16, 2011.

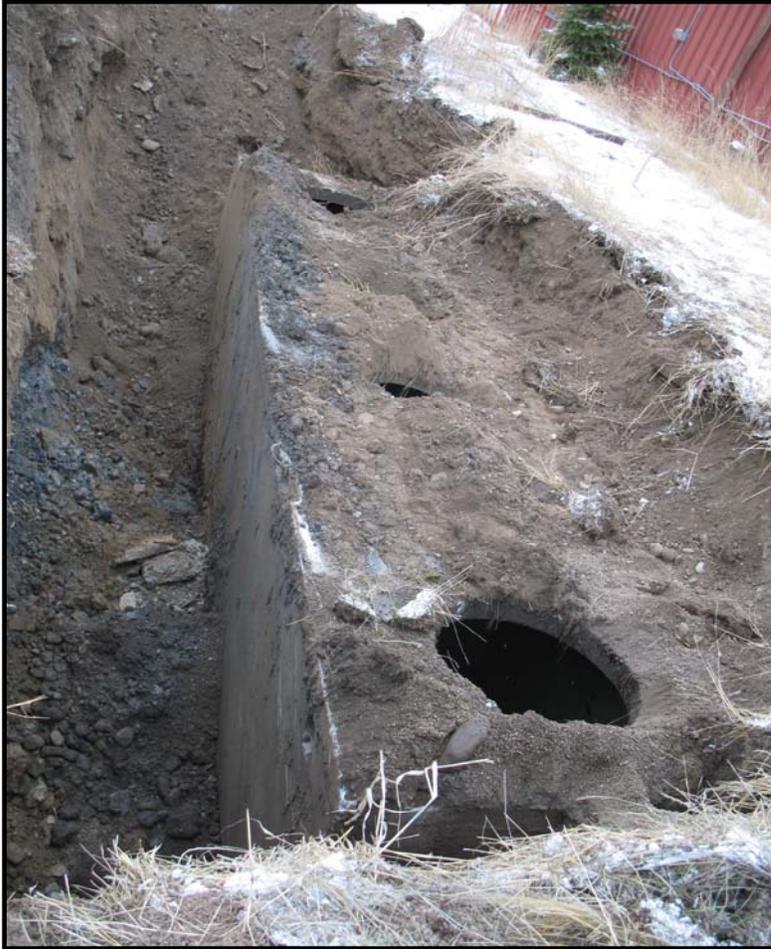
Photograph No. 5 (left) - View toward the east showing extend of 4 compartment oil-water separator. Photo by AWC December 16, 2011.

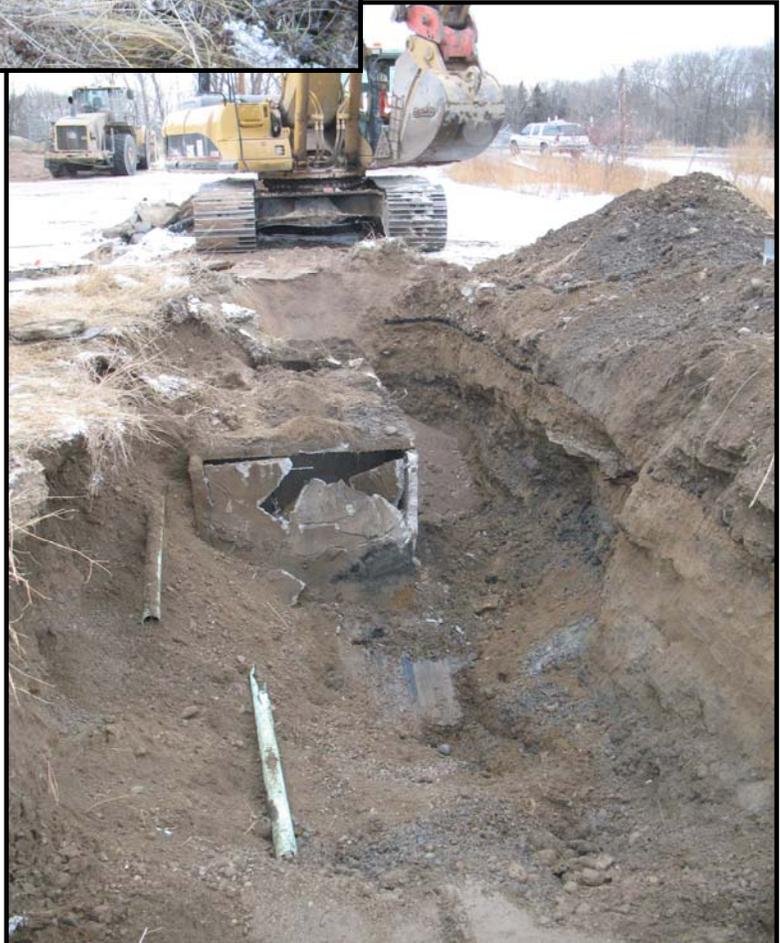
Photograph No. 6 (right) - View toward the west showing subsurface soil conditions after east oil-water separator tank was removed. Photo by AWC December 16, 2011.

Inspection of the tank basin determined that no soil staining or odors were observed in the soil underlying the oil-water separator. A composite soil sample was collected beneath each tank at a depth of 10 feet below ground surface (bgs). The samples are respectively designated as Base of East Tank and Base of West Tank. A layer of gray to black stained soil was observed on the north wall of the excavation at a depth of 5 feet bgs (see photograph no. 8 in Appendix A). Although the soil was discolored, it did not have a petroleum odor but rather a sewer odor. A soil sample was collected from this area and designated as North Wall (see **Figure 2**). The three soil samples were shipped on ice with appropriate chain-of-custody documentation and seals to Energy Laboratories in Billings, Montana. The samples were submitted for the following analyses:

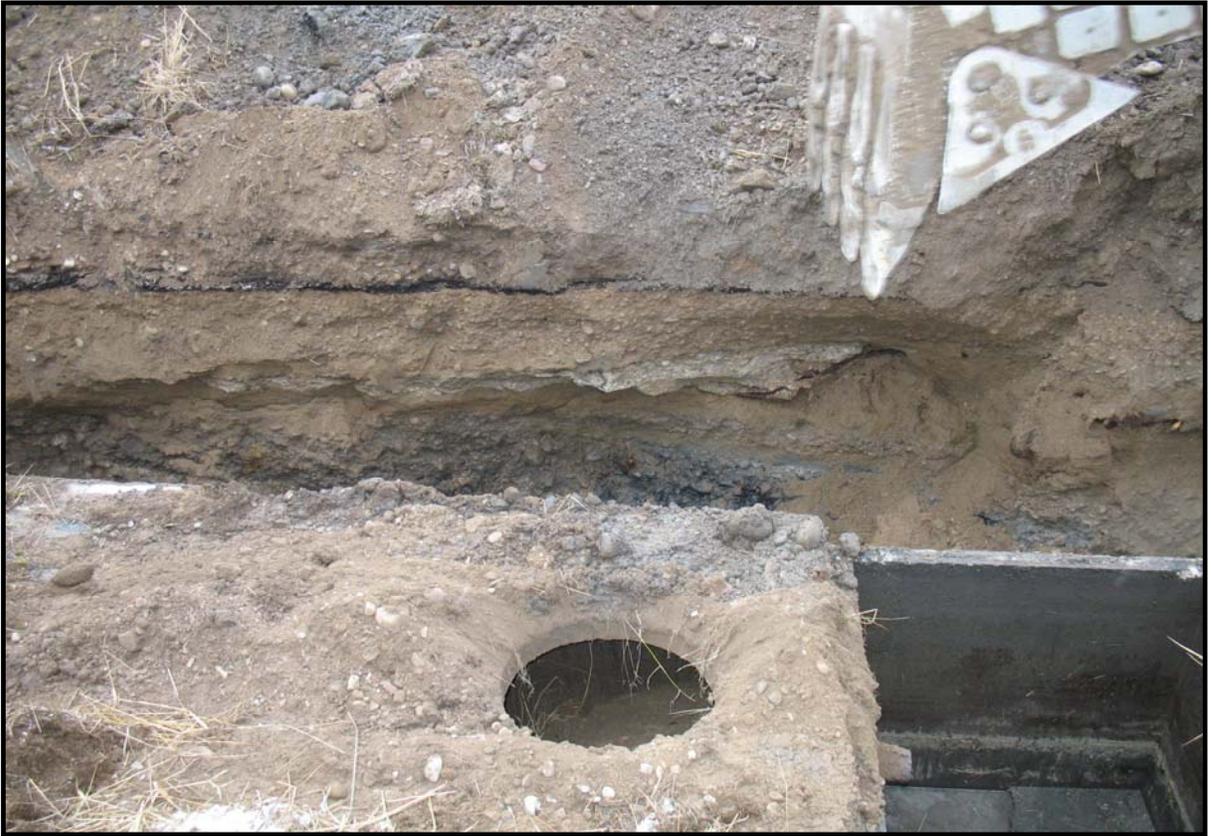
Photograph No. 7 - View of oil-water separator excavation and removal. The cover of the east tank has been removed. Photo by AWC December 16, 2011.

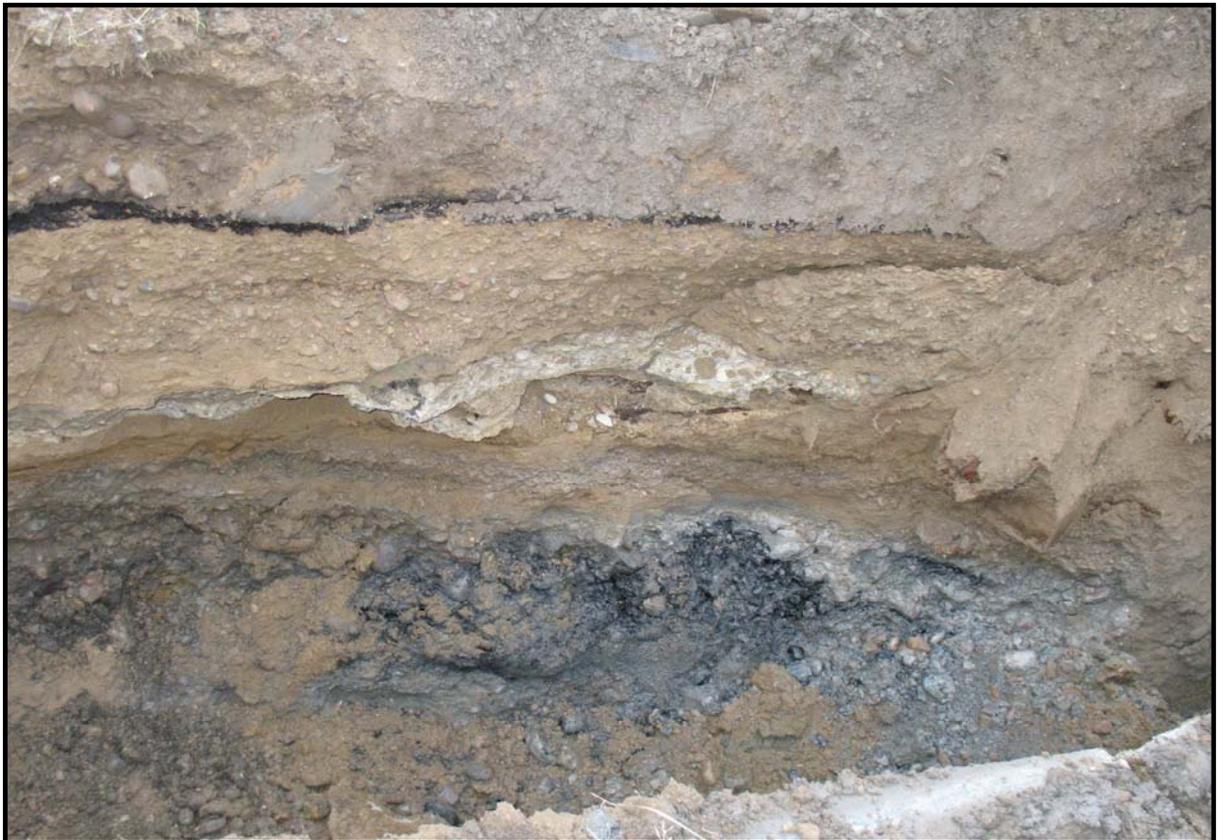
Photograph No. 8 - View of discolored soils on north wall of excavation. Black line in upper part of photograph is layer of asphalt from current road surface. Photo by AWC December 16, 2011.

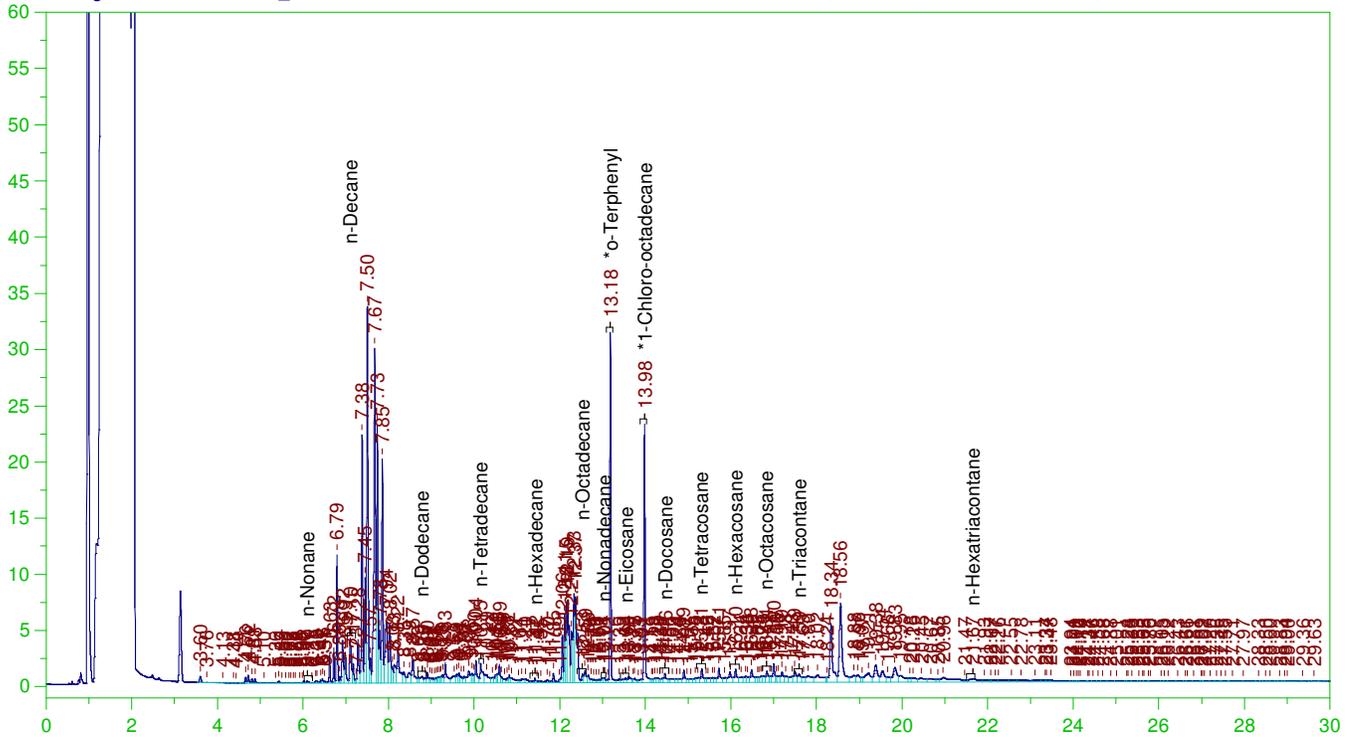
**EXTRACTABLE PETROLEUM HYDROCARBONS (EPH) SCREENING ANALYSIS CHROMATOGRAM**

Sample Name: B11121745-001A ;1219FIS , \$HC-EPH-SCRN-S,  
Raw File: G:\Org\FIS\DAT\FIS121911\_b\1219FIS.0058.RAW  
Date & Time Acquired: 12/21/2011 6:55:35 PM  
Method File: G:\Org\FIS\Methods\S3000WV-L%.met  
Calibration File: G:\Org\FIS\Cals\SC090901WV.CAL  
Sample Weight: 30 Dilution: 2 S.A.: 1

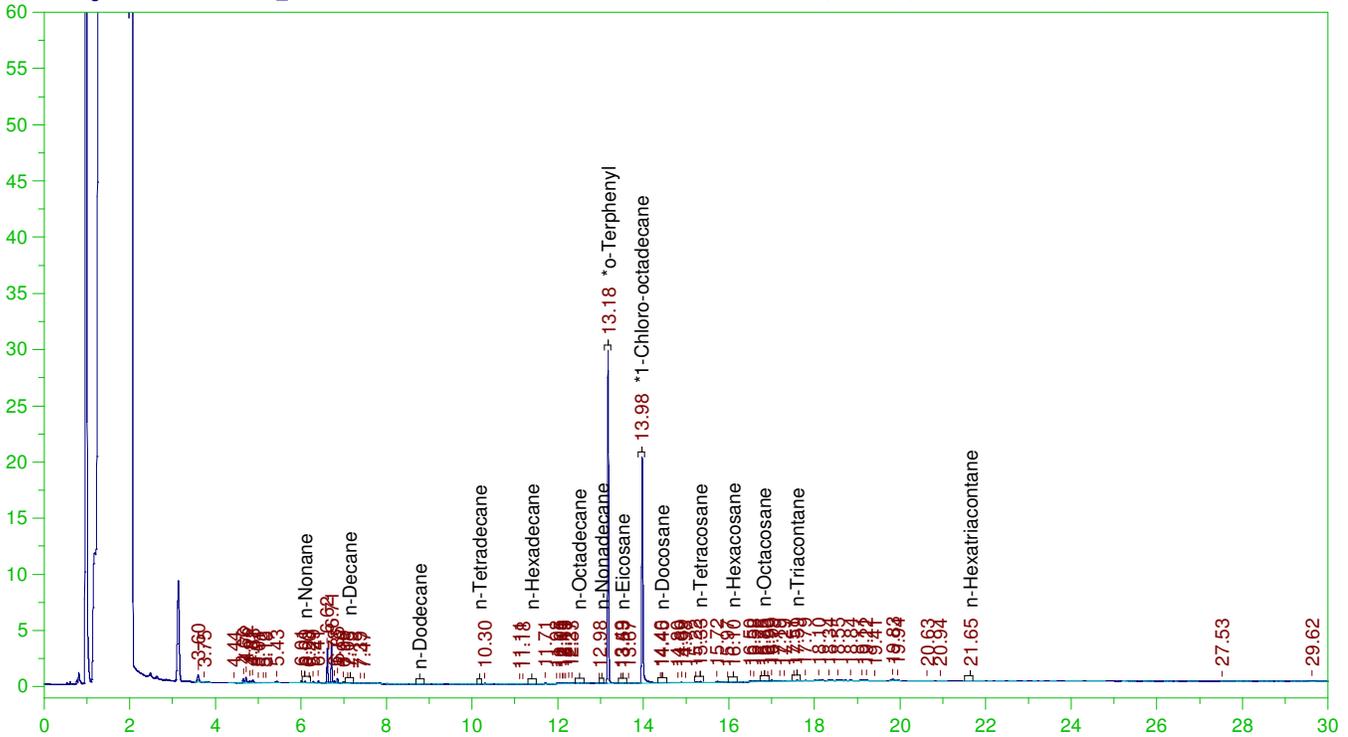
**EXTRACTABLE PETROLEUM HYDROCARBONS (EPH) SCREENING ANALYSIS CHROMATOGRAM**

Sample Name: B11121745-002A ;1219FIS , \$HC-EPH-SCRN-S,  
Raw File: G:\Org\FIS\DAT\FIS121911\_b\1219FIS.0056.RAW  
Date & Time Acquired: 12/21/2011 5:11:31 PM  
Method File: G:\Org\FIS\Methods\SR000WV-L%.met  
Calibration File: G:\Org\FIS\Cals\SC090901WV.CAL  
Sample Weight: 30 Dilution: 2 S.A.: 1

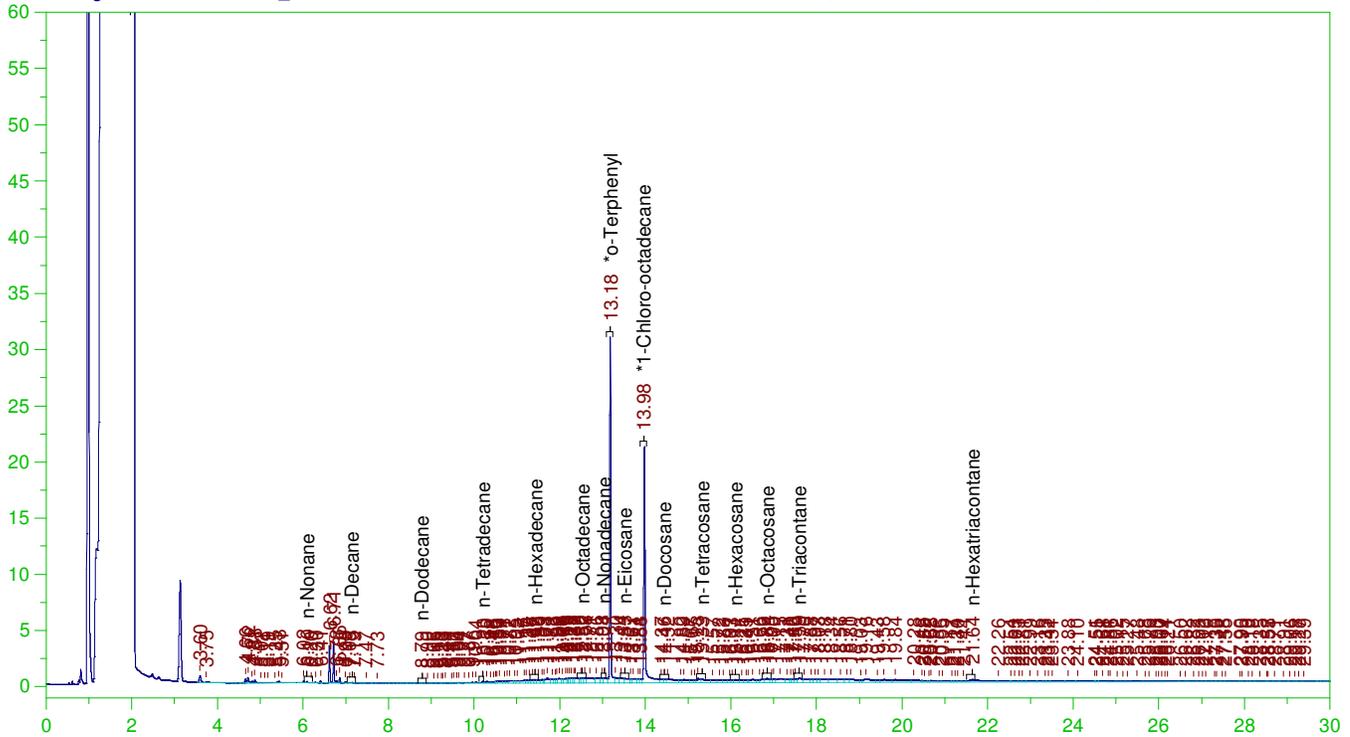
**EXTRACTABLE PETROLEUM HYDROCARBONS (EPH) SCREENING ANALYSIS CHROMATOGRAM**

Sample Name: B11121745-003A ;1219FIS , \$HC-EPH-SCRN-S,  
Raw File: G:\Org\FIS\DAT\FIS121911\_b\1219FIS.0057.RAW  
Date & Time Acquired: 12/21/2011 6:03:34 PM  
Method File: G:\Org\FIS\Methods\S3000WV-L%.met  
Calibration File: G:\Org\FIS\Cals\SC090901WV.CAL  
Sample Weight: 30 Dilution: 2 S.A.: 1
